Fire Aboard the M.S. SCANDINAVIAN SEA
on March 9, 1984
Technical Assessment

USCG CITS-85-1-1

14. Sponsoring Agency Code		15. Supplementary Notes This technical report was prepared as background material for the Marine Board of Investigation that examined the SCANDINAVIAN SEA FIRE of March 9, 1984.

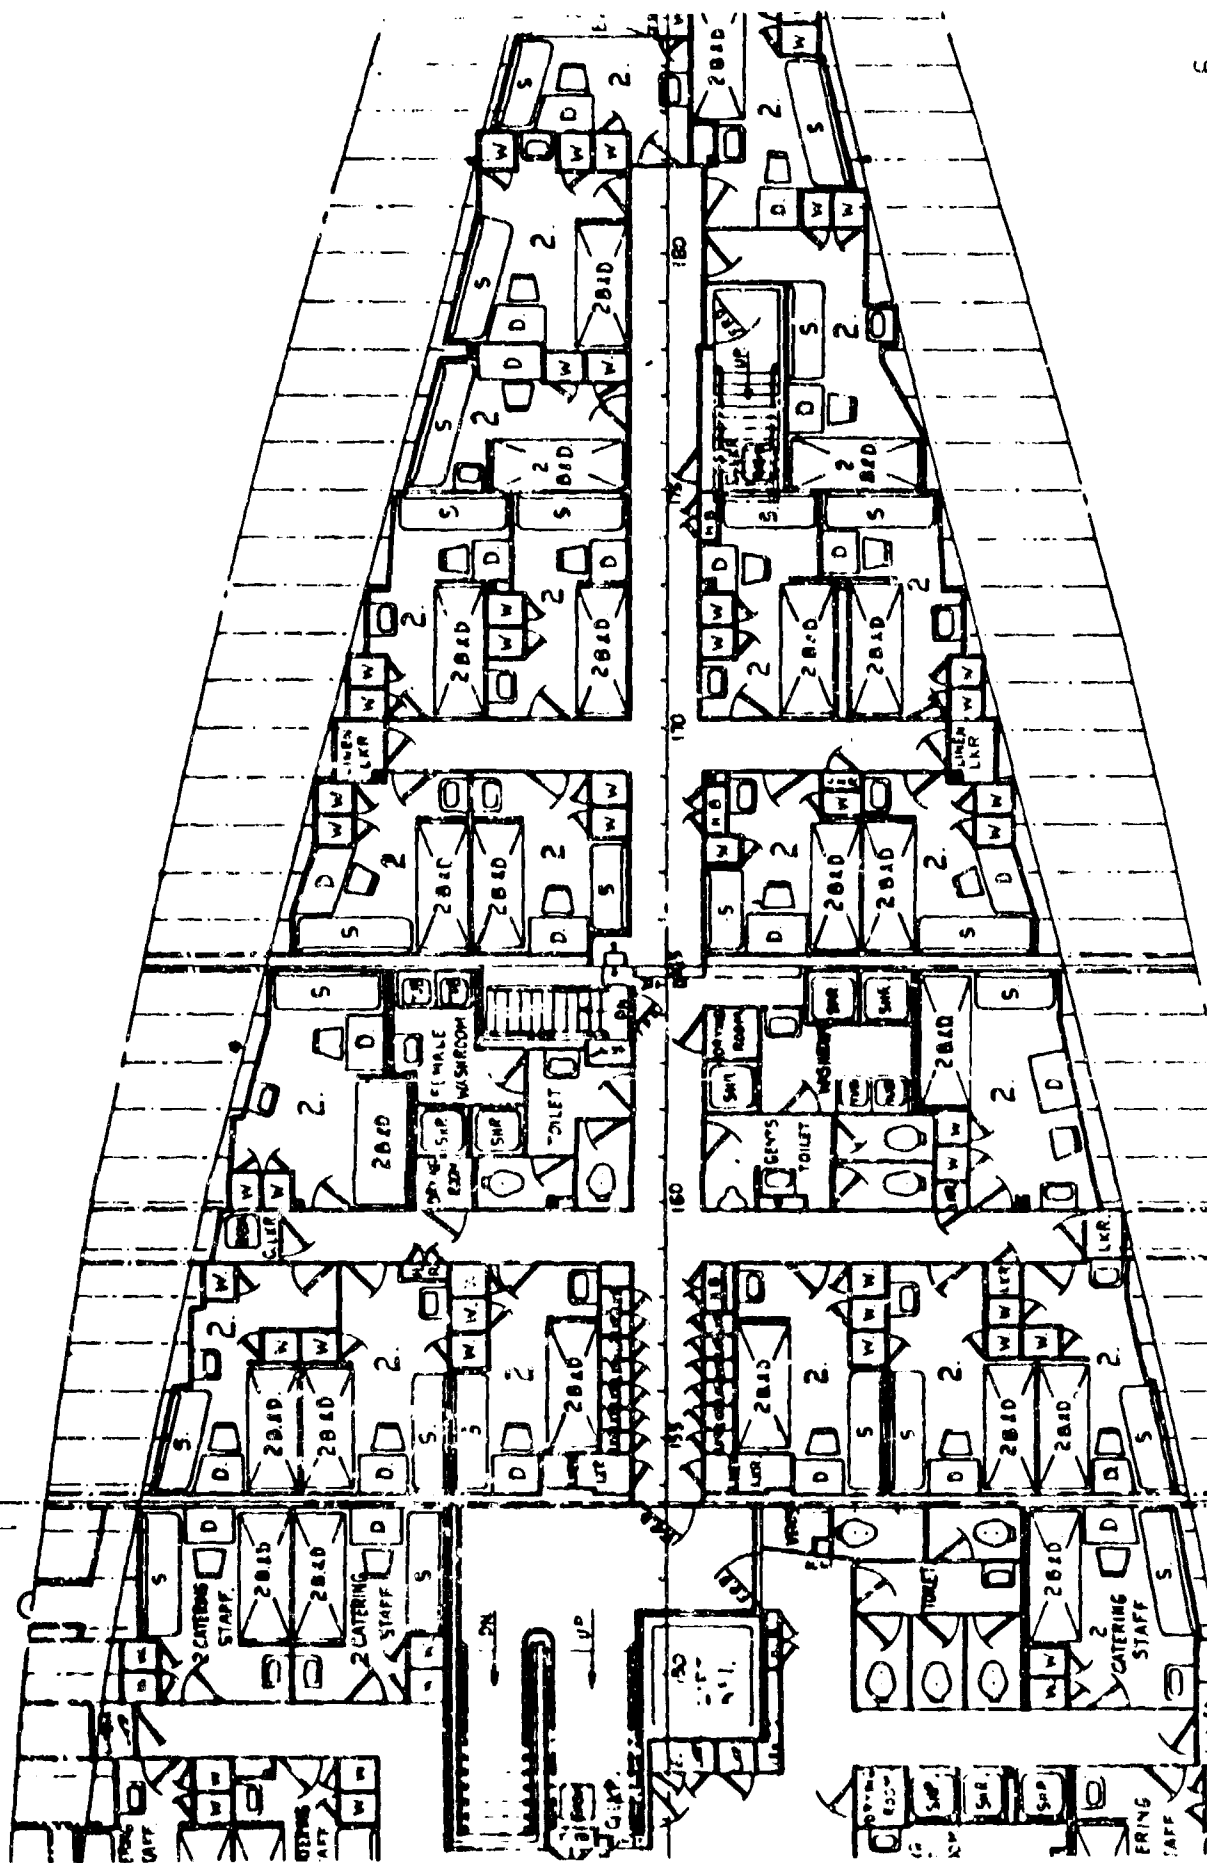
FIGURE 5
"A" DECK

Extensive fire damage occurred on "A" deck, the main deck, the upper deck and the lounge deck. These decks, forward of the fire door at frame 153 (see Figure 5), were eventually gutted in several areas. Some smoke and water damage also occurred aft of this position.

All fire doors that were activated from the bridge had automatic closers. The location of these doors is shown on Figures 2 through 5. Fire propagation as determined by heat and fire damage suggests that the stairtower fire door at frame 179 on "A" deck, was left open early in firefighting operations. A fire hose had also been left in this door opening. This open door probably aided transmission of heat and combustible gases to the deck above.

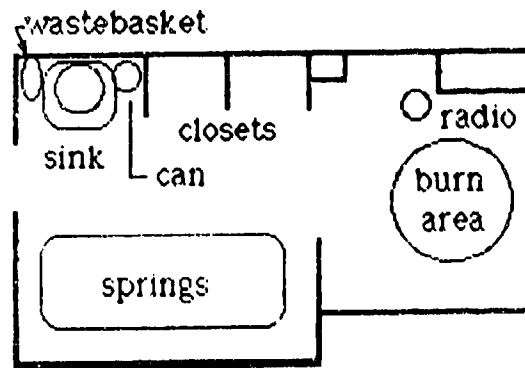
Figure 7 - Schematic of room 414

The remains of the radio (speaker frame) are shown in upper left part of Photograph 10 just above the water line. The approximate location of this radio relative to the desk is shown in Figure 7 below.
